## Management of Natural Disaster Mitigation and Response Programs for Historic Sites

# 1994 Northridge Earthquake: case study, Los Encinos State Historic Park, Garnier Building

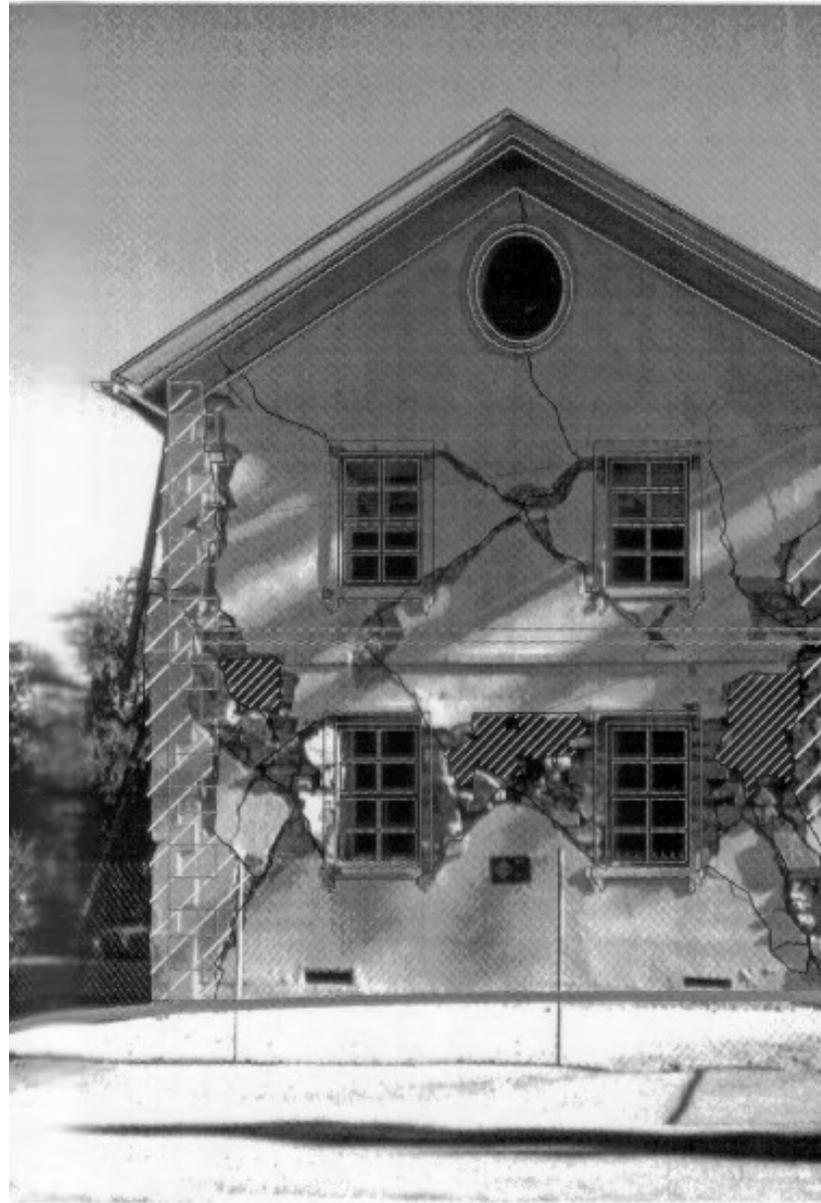
**North elevation.**

The north elevation suffered severe cracking such that the area between the lower windows collapsed, leaving two small piers of masonry supporting the continuous header over the windows. The building corners, which had no anchors within the width of the wall, dislodged and are immanently in danger of collapse. The lack of corner anchors has been noted as a deficiency and current unreinforced masonry design includes corner anchors. The masonry above the second-floor windows remains in good condition with little cracking. This masonry was tied into the roof and second-floor ceiling structure during the retrofit.
